## OWNER-BUILDER DEFECTS REPORT (137B REPORT)

**Prepared for Clients:** Client Name  
**Inspection Address:** 7 Test Street, Camberwell, Vic 3124  
**Date of Inspection:** Date of Inspection  
**Inspector:** Inspector Name  
**People Present:** People Present  
**Weather Conditions:** Light Rain – Cloudy  
**Orientation of Building:** The front of building faces West

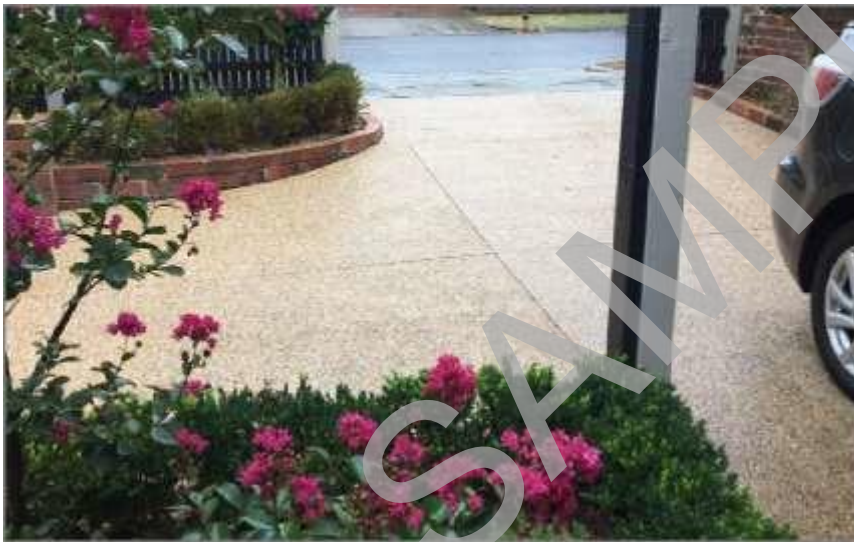
### Driveways

**Image:** New concrete drive and path in good condition.

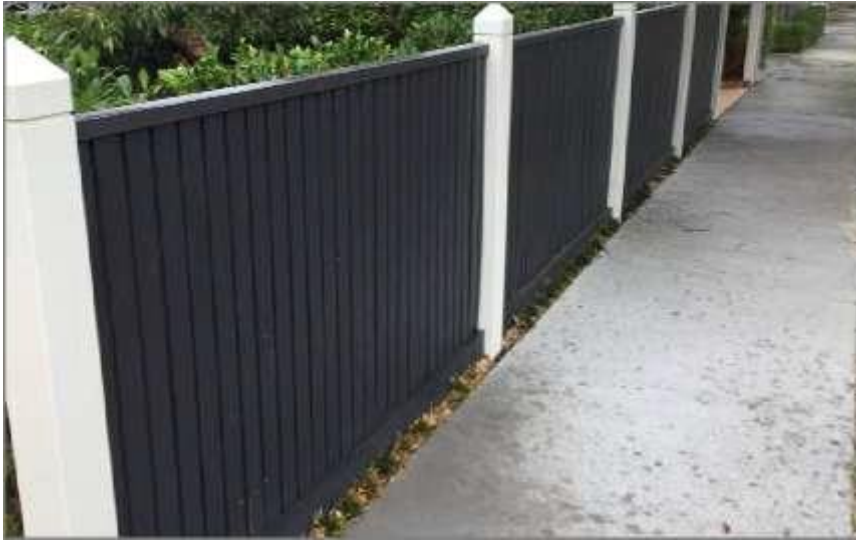
**Fences**

**Image:** New front fence in good condition.

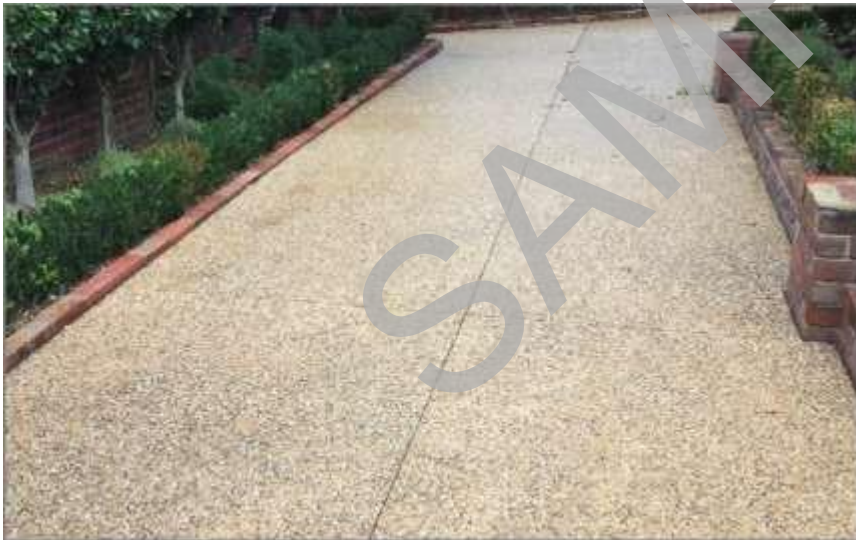
**Paths**

**Image:** New concrete drive and path in good condition.

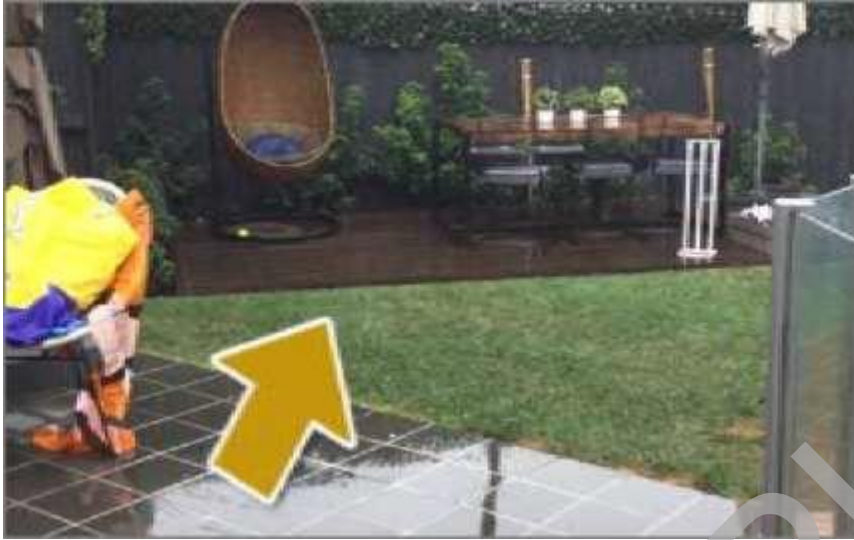
### Floor

**Image:** Timber deck in good condition.

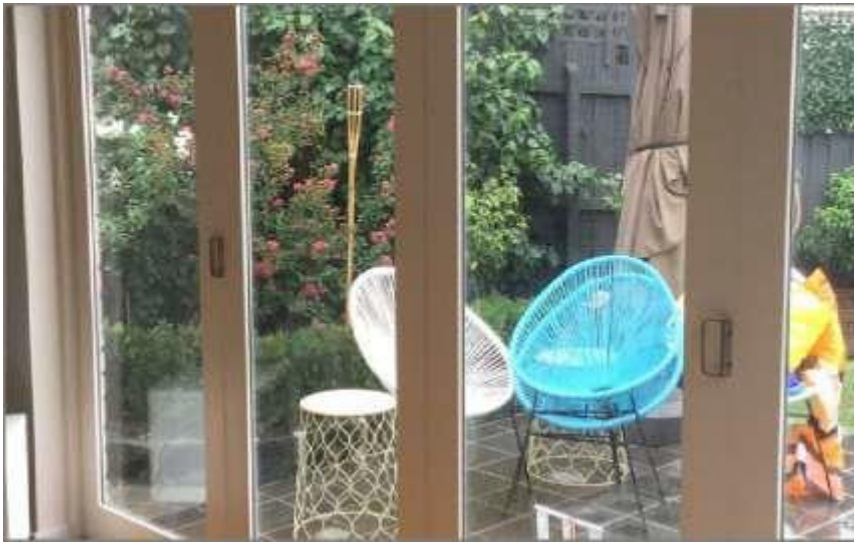
**Doors**

**Image:** New bi-fold doors in family room in good condition.

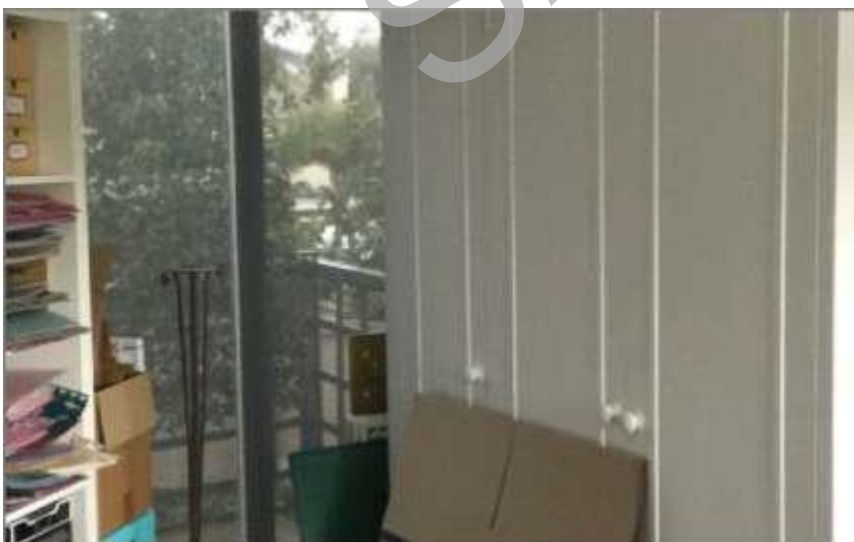
**Robes**

**Image:** Walls, floor, ceiling, and cupboards in good condition.

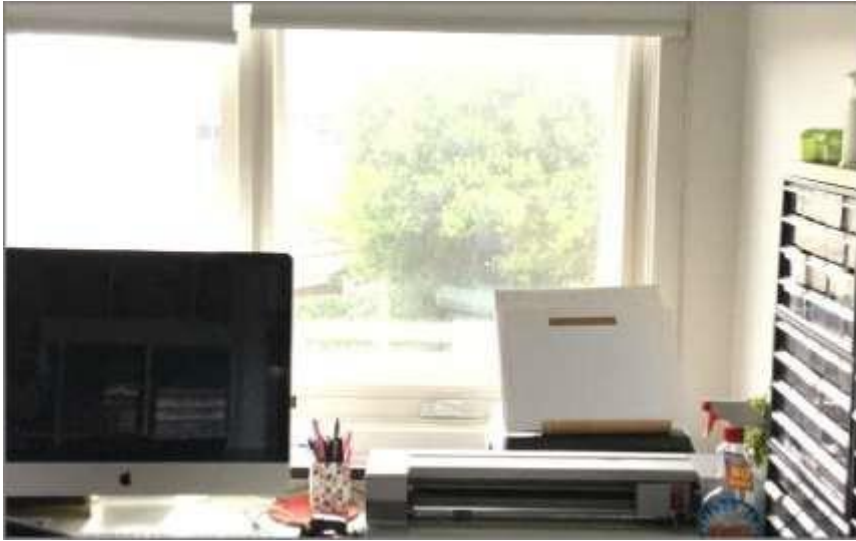
## Windows

**Image:** Walls, floor, ceiling and window in good condition.

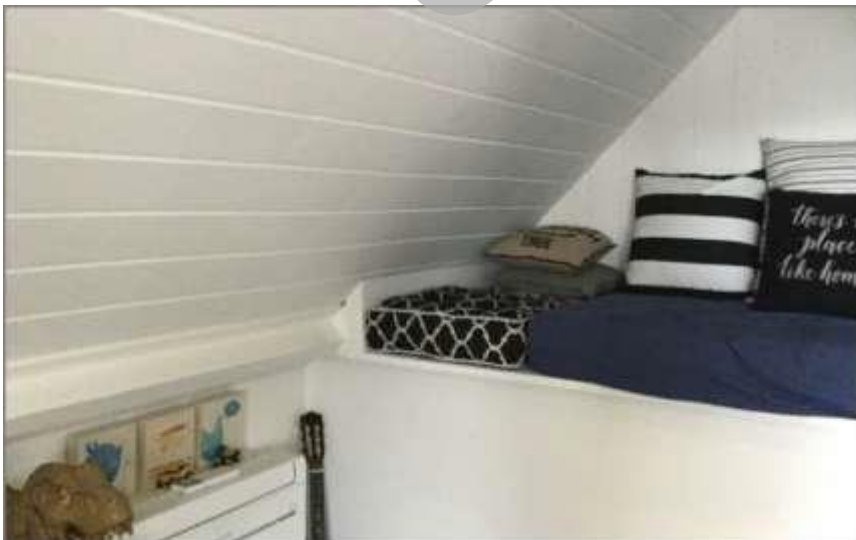
## Ceiling

**Image:** Walls, floor and ceiling in good condition.

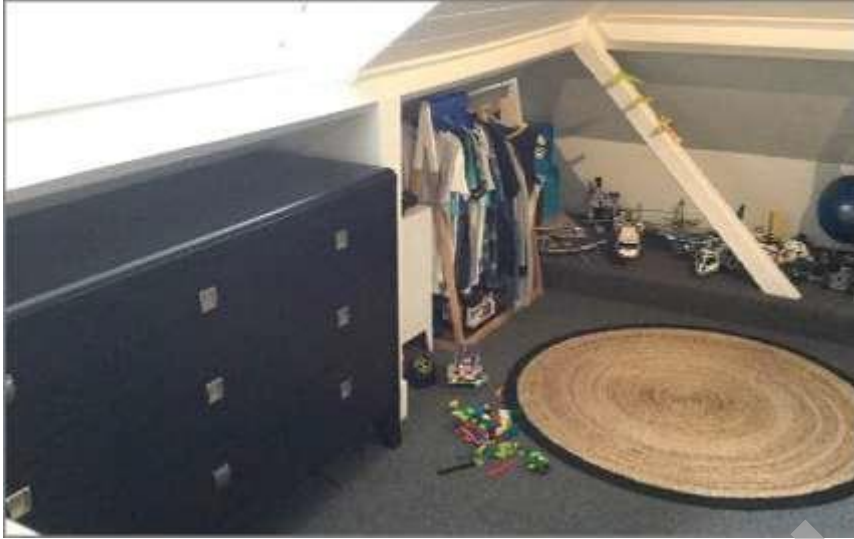
**Walls**

**Image:** Walls, floor and ceiling in good condition.

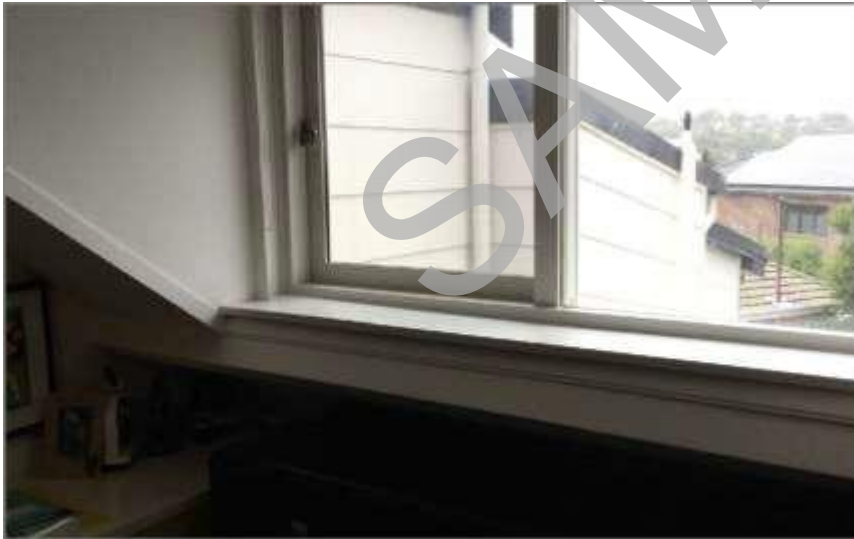
**Windows**

**Image:** New timber window installed and in good condition.

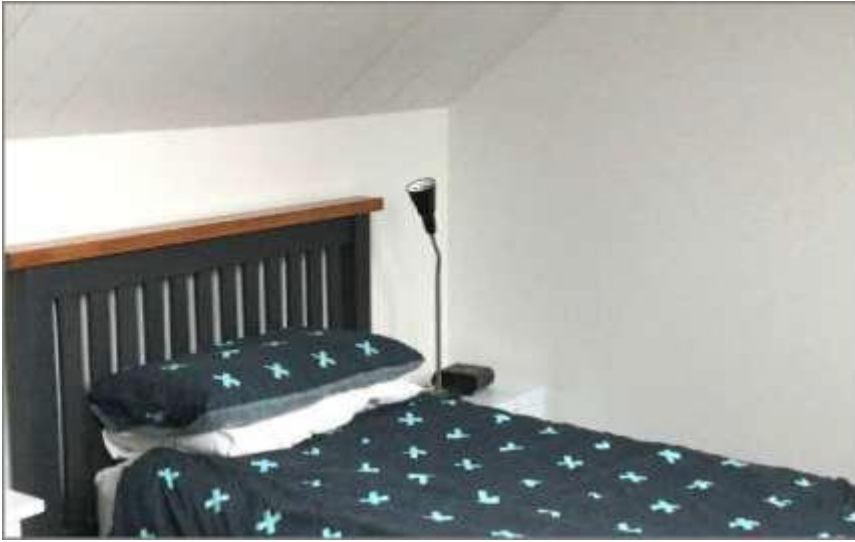
## Ceiling

**Image:** Walls, floor and ceiling in good condition.

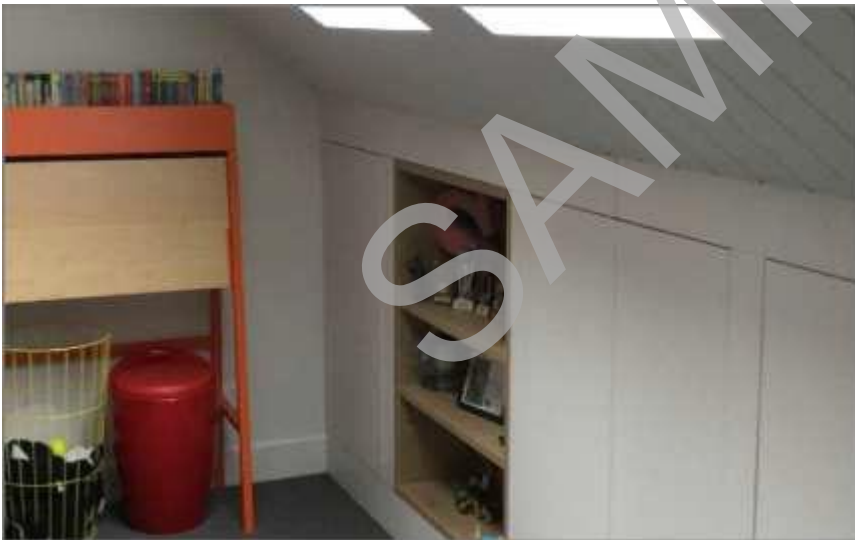
## Walls

**Image:** Walls, floor and ceiling in good condition.

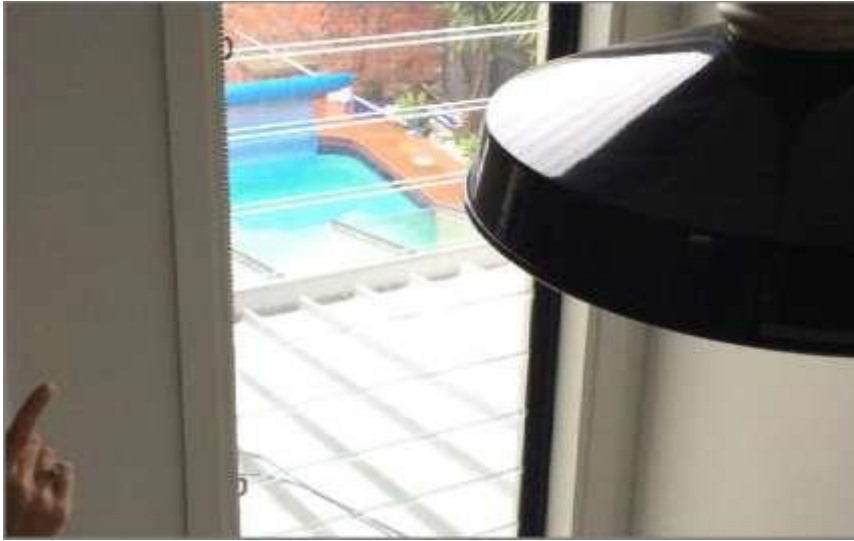
## Windows

**Image:** New window in good condition.

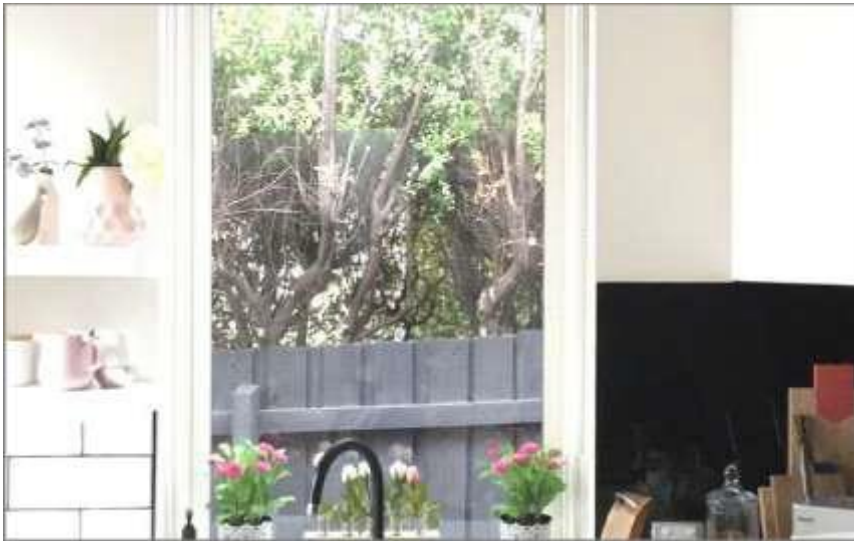
## Windows

**Image:** New window in kitchen in good condition.

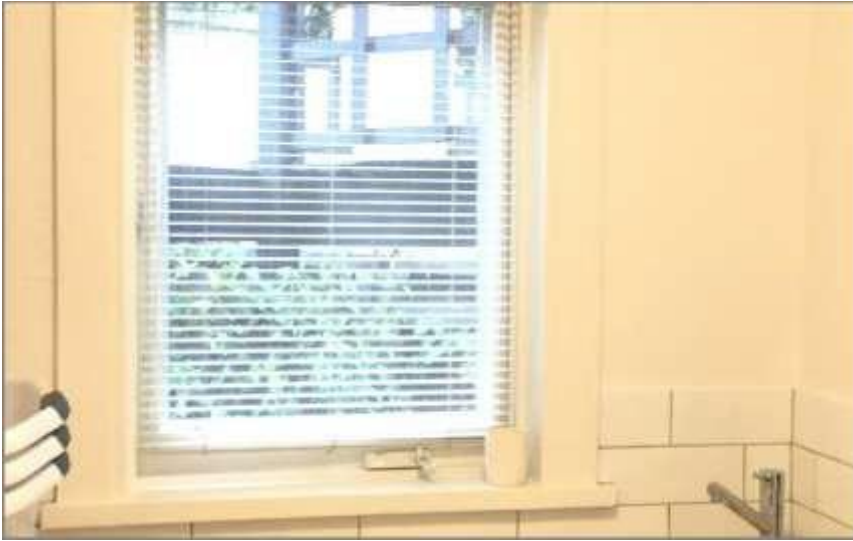
## Windows

**Image:** New windowing laundry in good condition
